**Modeling the O&W**  
**No. 43 in a Series**  
**The Wreck of No. 70 at Luzon**  
**March 13, 1907**

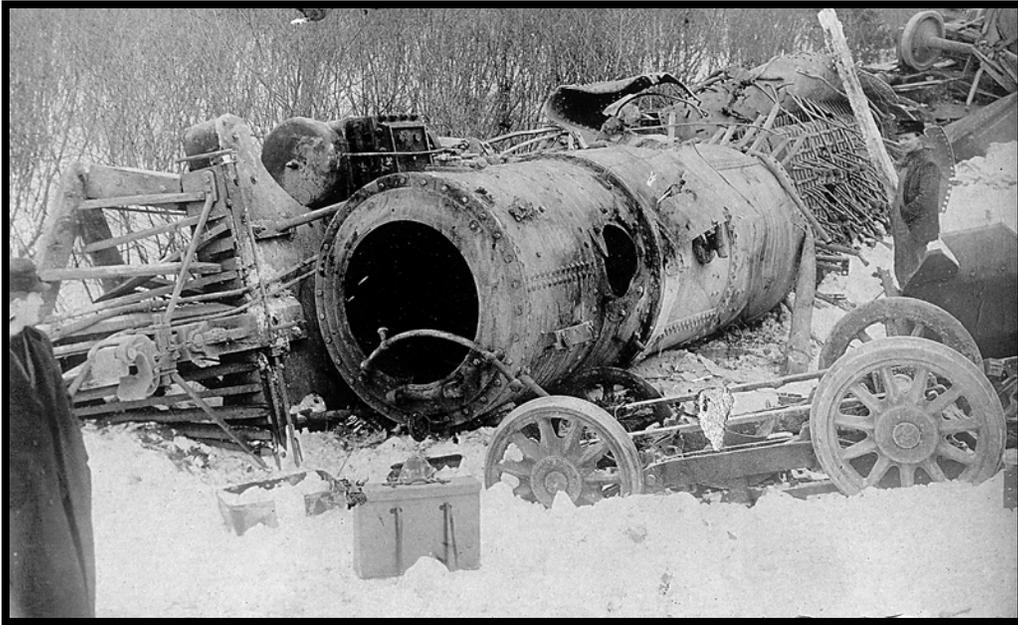
*The above image is one of several well publicized views taken from at or near identical photographer locations. The firebox is to the rear of the engine hulk (in the upper tight quadrant of this image) and the wreckage is of the boiler carcass peeled away exposing the flue ends at the rear flue sheet, and the many smaller water tubes above the Crown sheet and the remnants of staybolts which formerly supported the Crown sheet from the boiler carcass above the firebox. While many copies of this image are extant, this particular copy came from the collection of Bob Harding and now resides in the author's collection.*

The officials of the O&W stated again this morning that there is no known cause for the boiler exploding and particularly for the explosion being such a shattering one. It is practically certain that there was plenty of water in the boiler as water was taken at Fallsburgh, three miles this side of where the accident occurred. . ."

So, here are two conflicting reports and accounts of the boiler explosion of No. 70, but then with the newspaper accounts injecting yet another possibility; -- that of an explosive remnant and contaminant in the coal. As experienced an engineer as was Homer House (54 years in total, and within contained from 1902 to the end of steam operations on the O&W in 1948 on steam engines) I tend to doubt his explanation. Yes, there can be operating troubles if unevaporated liquid water is pulled through the "dry pipe" to cylinders, but (so far as water does not compress(!)) that generally would result in the hydraulic pressure blowing off a cylinder head. . . and not necessarily a catastrophic boiler explosion. In fact, Homer House, in another portion of the "Lost Tapes" describes one such an event with a "Bullmoose" where the cylinder head was blown off and fractured into small bits and pieces.

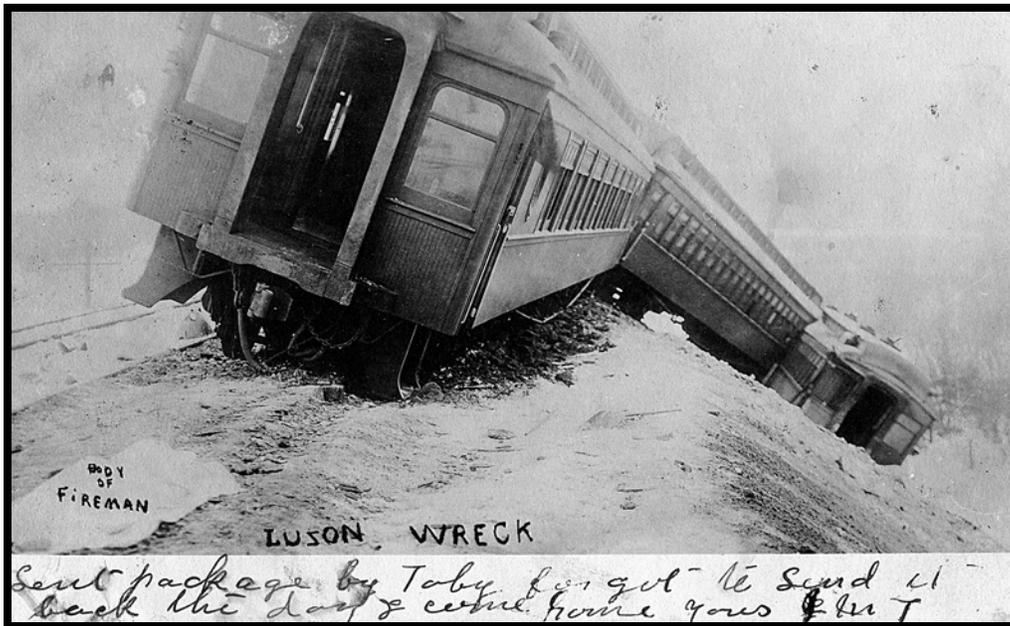
*In 1907, a time before the electronic information – communications means and methods we now nearly take for granted, a primary means to impart information was the photographic image. . . . and so virtually any sort of "news" was a suitable subject for photography and distribution in multiple copies (no different from today via 24 hour television news stations and the Internet). Postcards were a common and simple means of mail contact and quite unbelievably the Luzon wreck was a temporal and suitable postcard image subject! Although this card contains an image from the 1907 wreck it appears that its preparation was in accord with the pre-1900 US Postal regulations which forbade writing anything but a delivery address on the reverse of the card; -- and for the compliance of which senders' messages were inscribed upon the postcard fronts and often over the images of the card.*

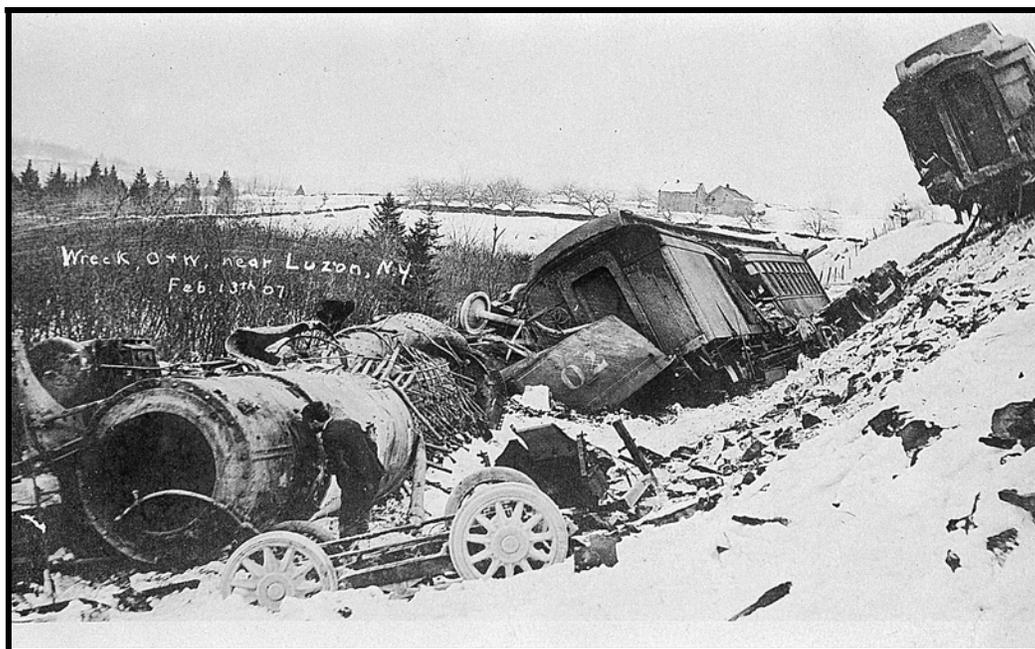
*Another view of the wreck is shown in this Real Postcard image, rendered by noted Liberty photographer Otto Hillig. Many O&W images were captured by different photographers to chronicle events locally deemed to be newsworthy, and this particular accident was among the more notable!*

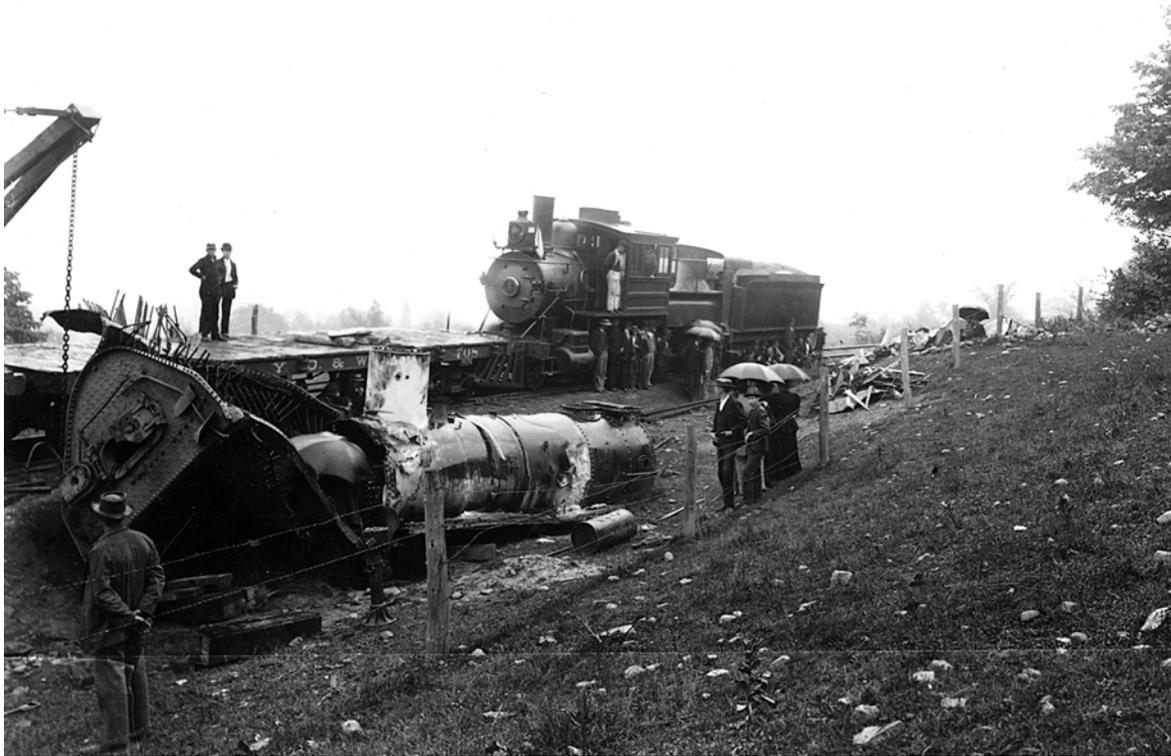
*Although rare, as above stated to emphasis and repetition, boiler explosions did occur on the O&W from time to time (one such additional accident being shown in an image published on Page 79 of the 2010 Observer "Center Cabs and Kitchens"). This image is of yet another unfortunate Eight Wheeler at an unidentified location (believed to be on the Scranton Branch). . . but of approximately the same era as the explosion of No. 70 as witnessed by the Class A Eight Wheeler Double Cab engine dispatched to duties of wreck clean up. The ferocity of the explosion can be inferred from the attitude of the boiler carcass as completely upside down "in the pasture!" The large circular casting in the smokebox is the "thimble" for the cylinder exhaust nozzle(s) running upward from the exhaust passages into the smokebox.*
